UNITED STATES DEPARTMENT OF AGRICULTURE

FOREST SERVICE

HEBGEN LAKE •• MADISON RIVER EARTHQUAKE DISASTER

AUGUST 1959

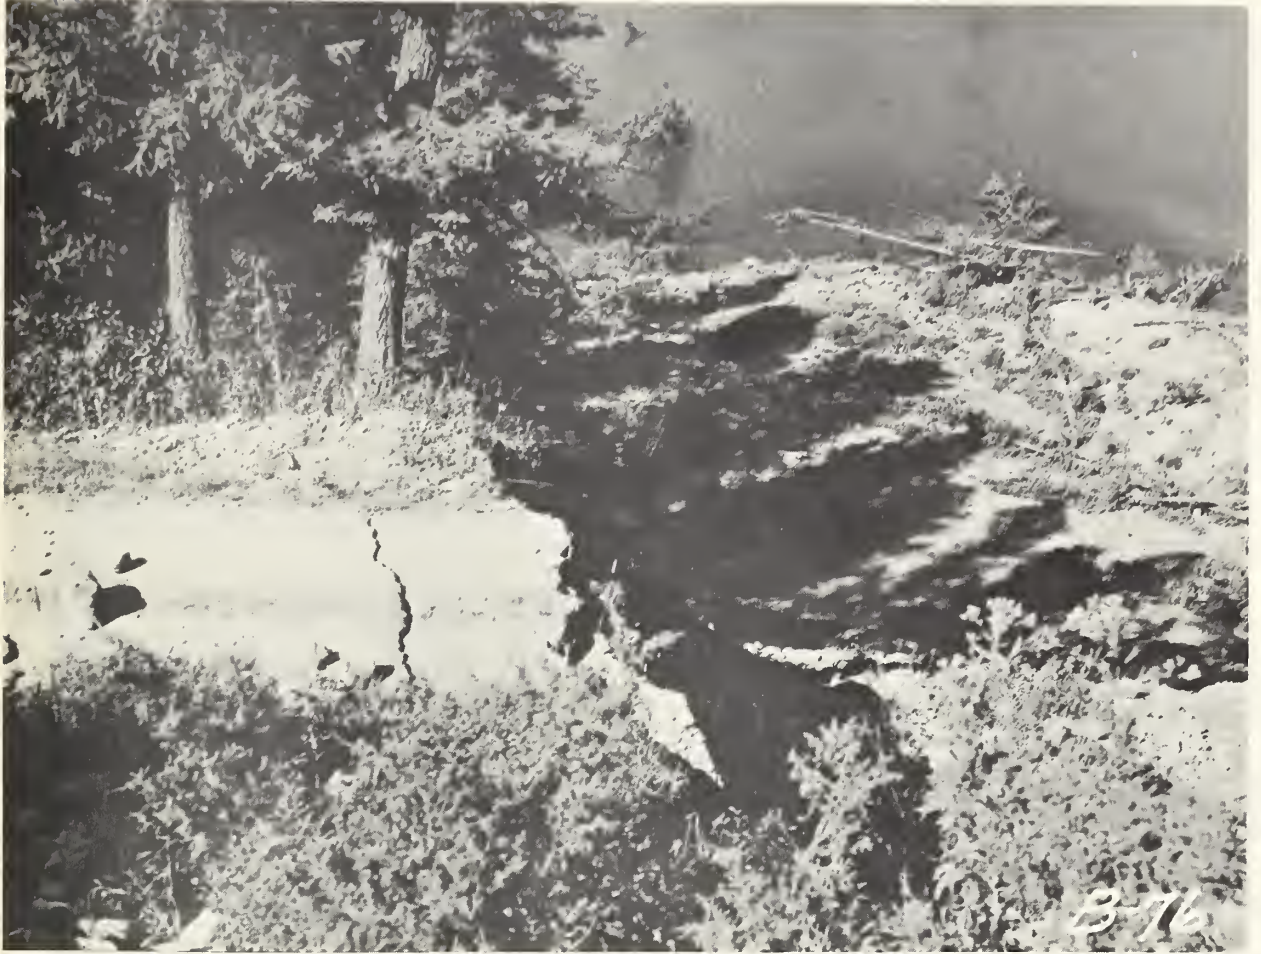
Wade Lake

Part of forest road taken out by slide.

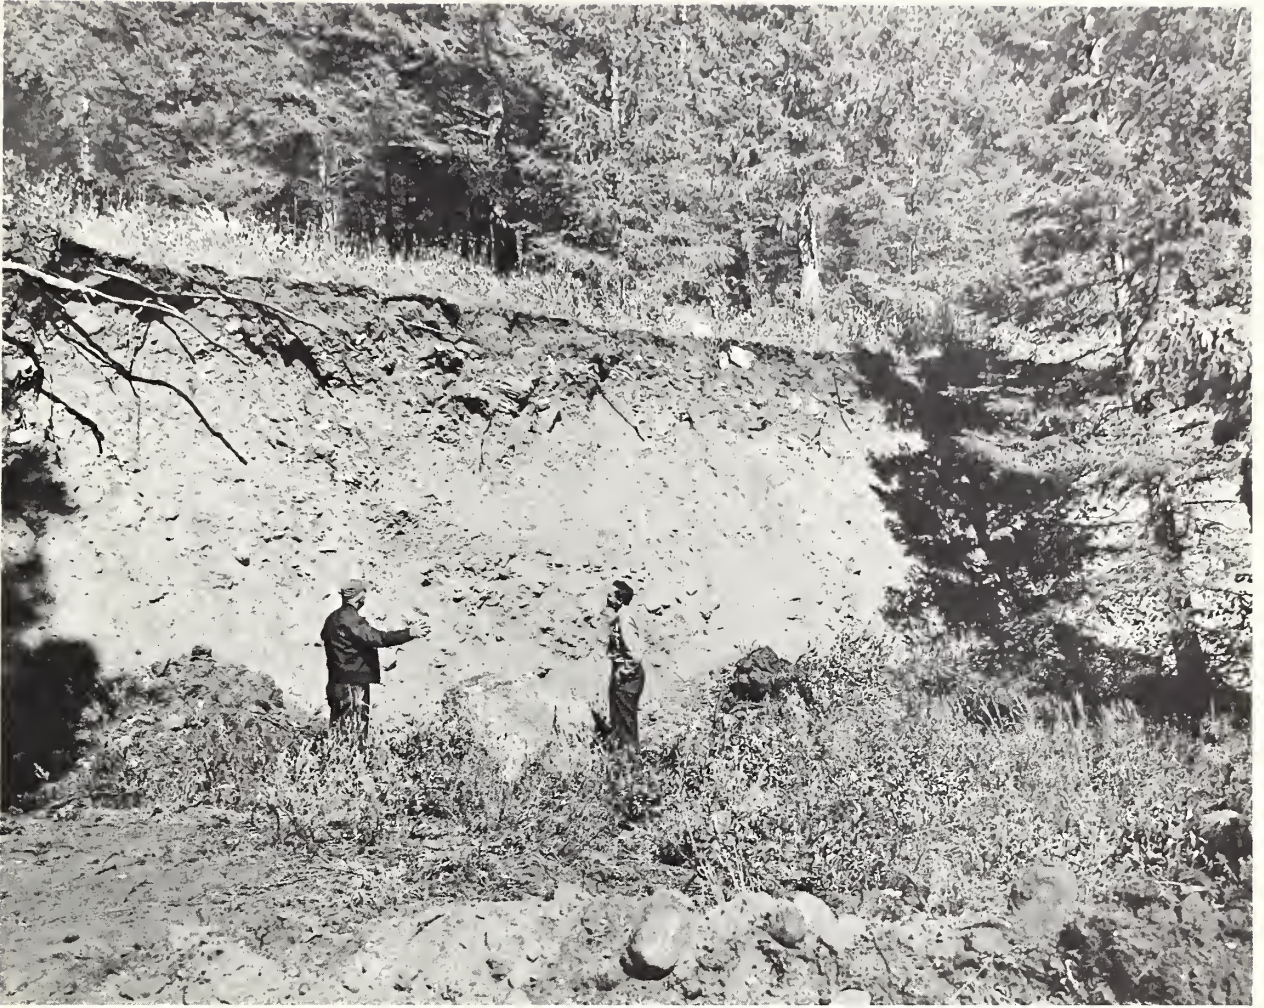
21-foot vertical displacement in Red Canyon near Hebgen Lake.

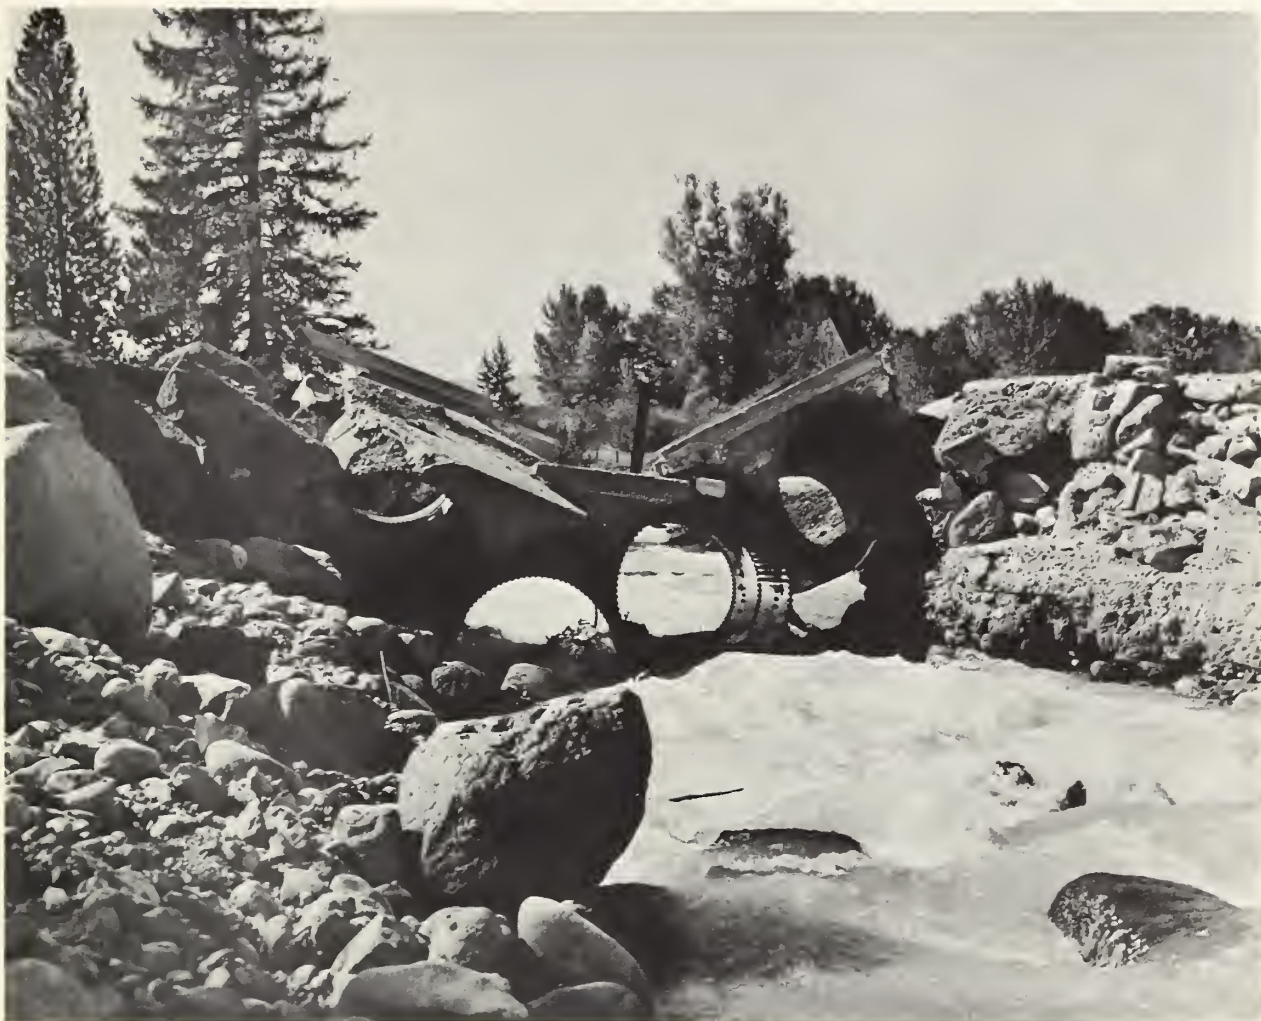
Collapsed culvert drainage structure on road at Culligan Ranch near Hebgen Lake.

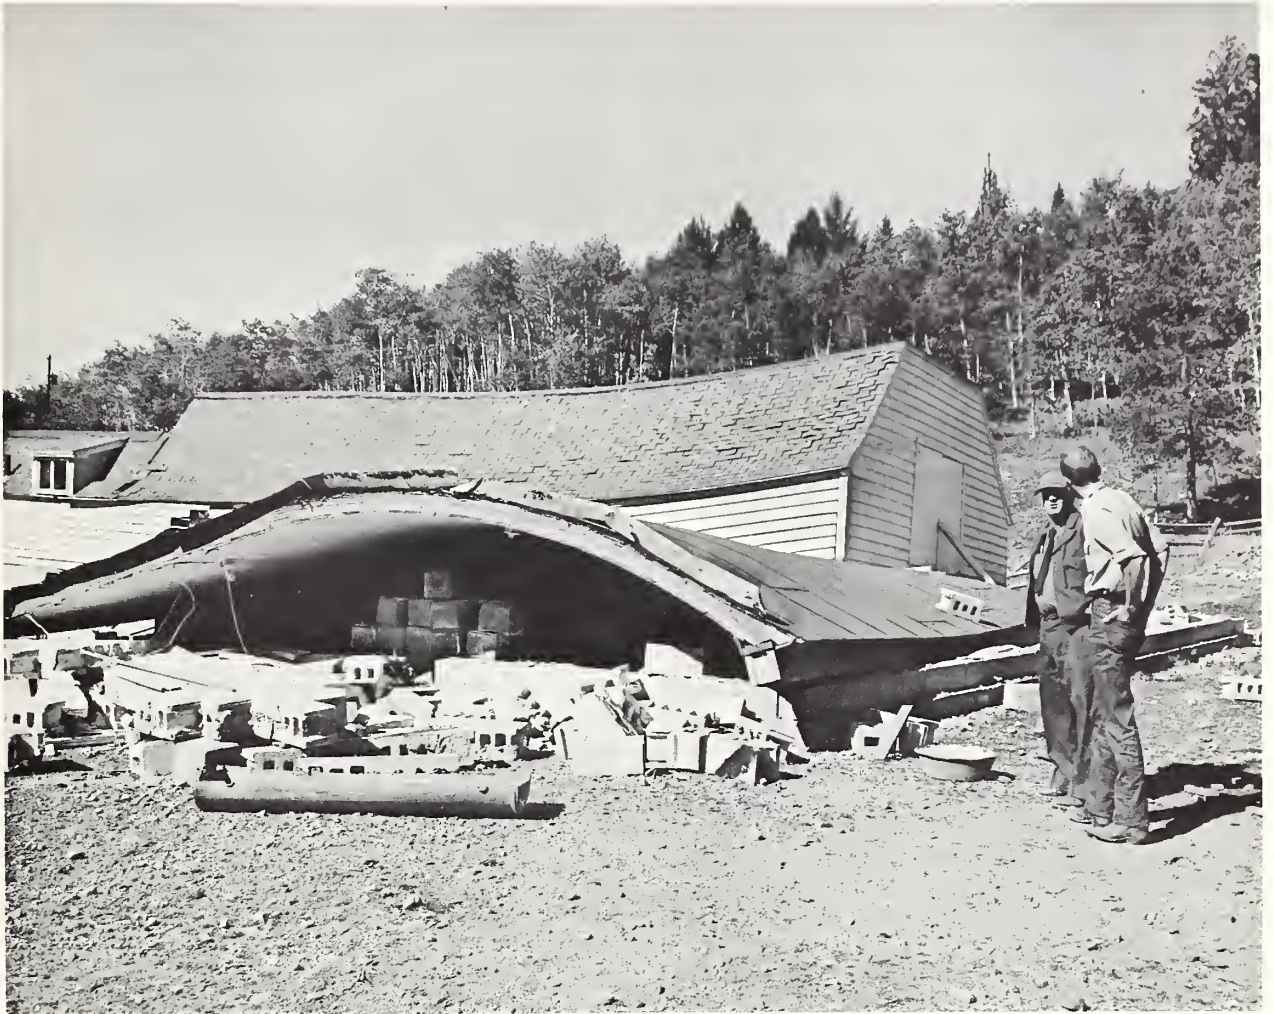
Roof of barn at Culligan Ranch, lying on ground.

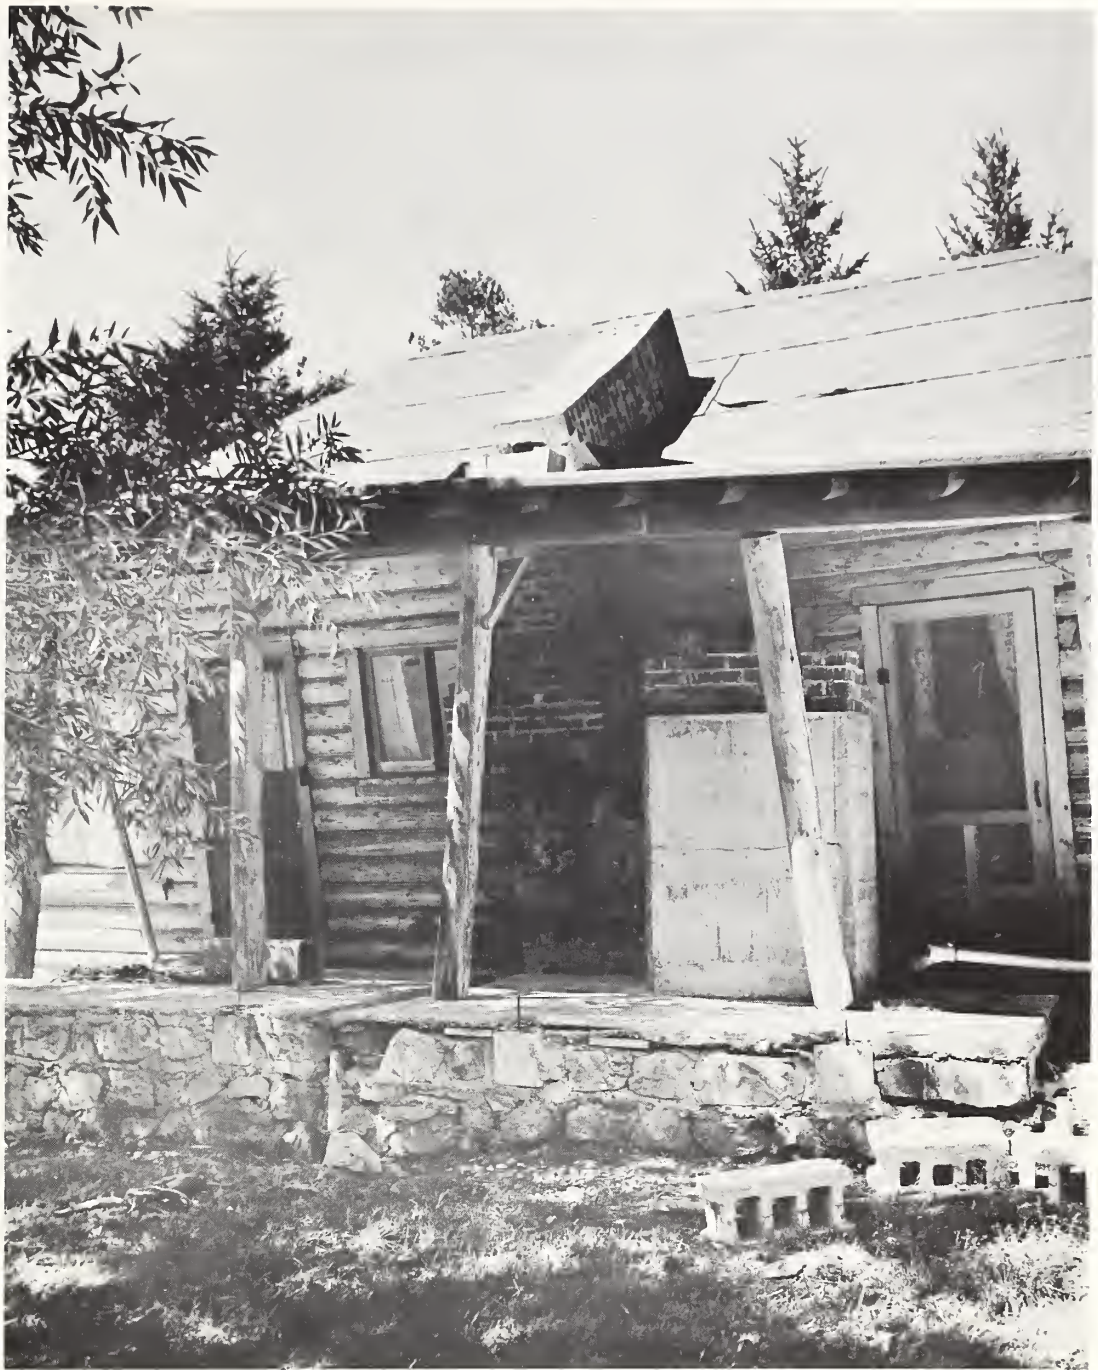
Damaged building on shore of Hebgen Lake. Note three sections of chimney.

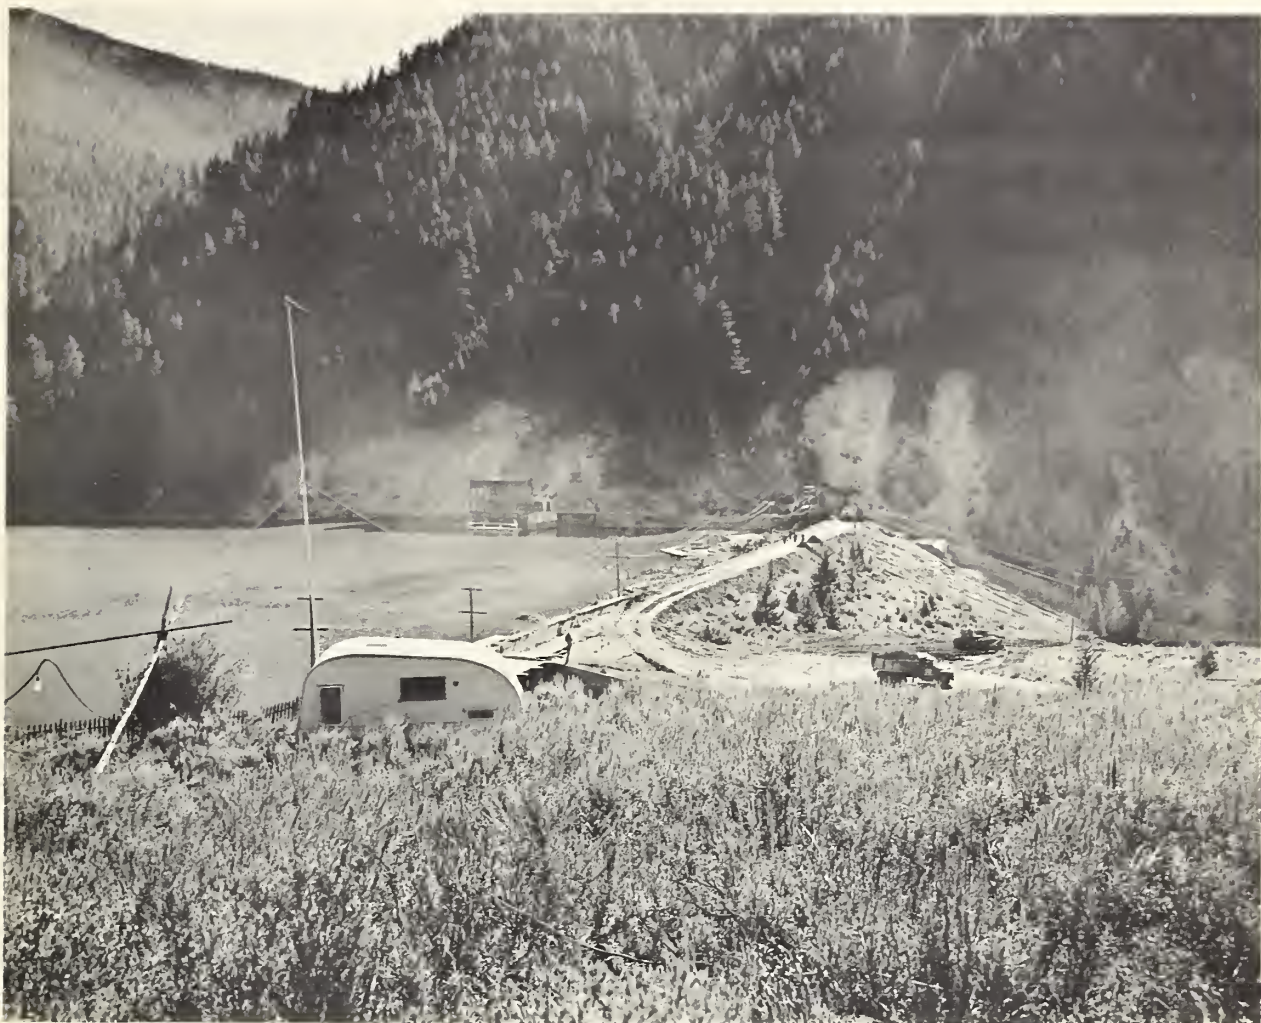
Forest Service radio point at Hebgen Dam for communications with West Yellowstone and Ennis. Equipment on dam is making repairs.

Montana Power Company representatives mobilized their organization to assist with examinations and emergency repairs at Hebgen Dam and communications from that vital point. Montana Power Company requested and immediately received assistance from the State Highway Department, the Bureau of Public Roads, and highway contractors Naranche and Konda who had considerable equipment on the Gallatin River Highway construction job.

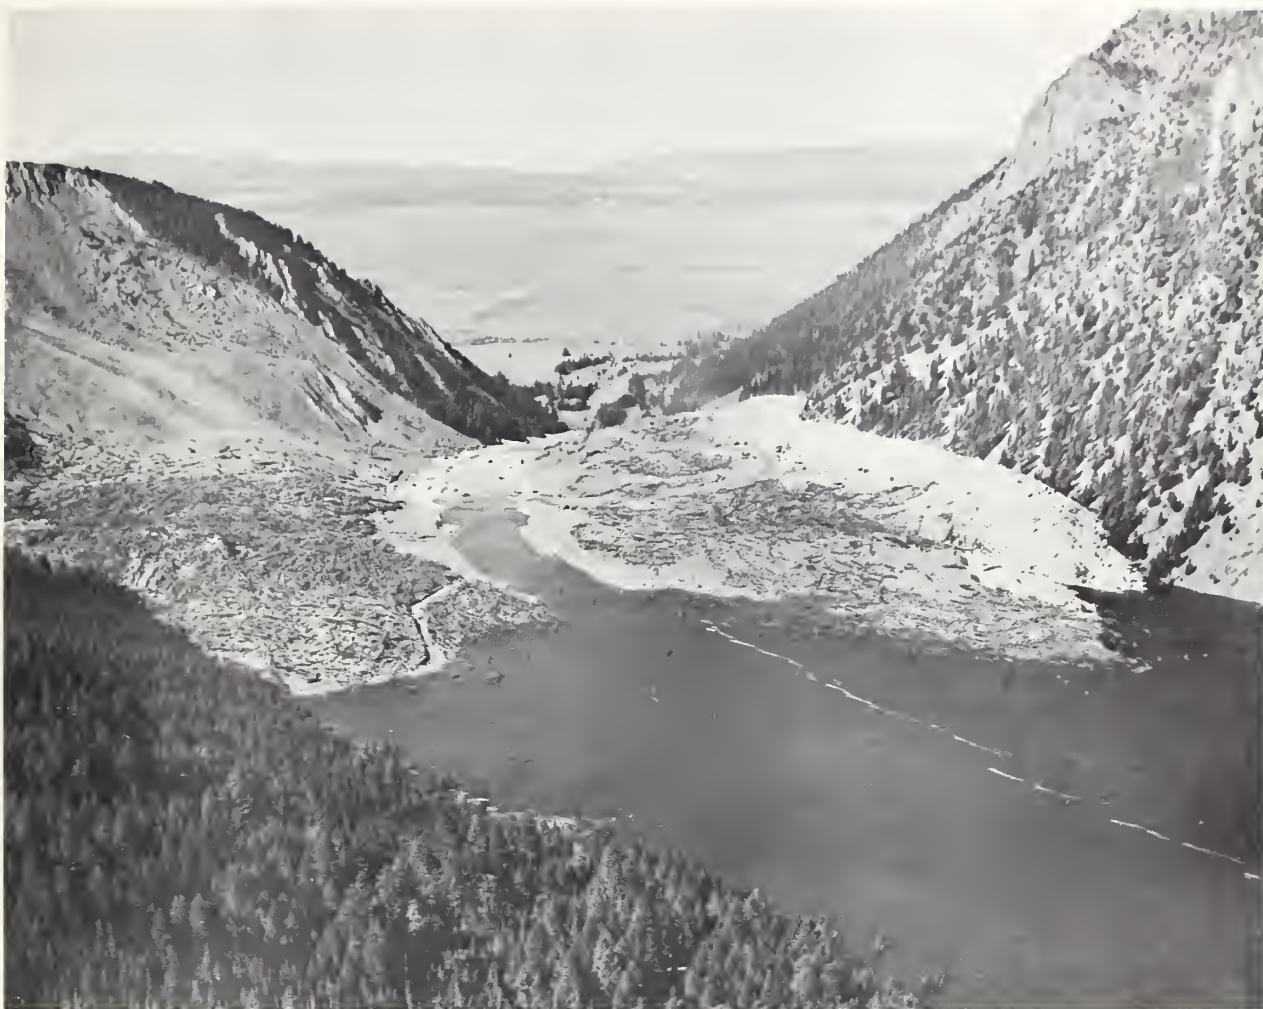
Water is beginning to flow over the crest of and down the front face of the earthquake slide through the spillway prepared by the Corps of Engineers. Time: Approximately 10:00 a.m., September 10, 1959.

The Army Engineers are engaged in constructing a rough road to the crest of the slide. The plan is to cut the crest down about 14 feet to prevent saturating the toe of the Hebgen Dam. This will provide a relatively smooth overflow channel.

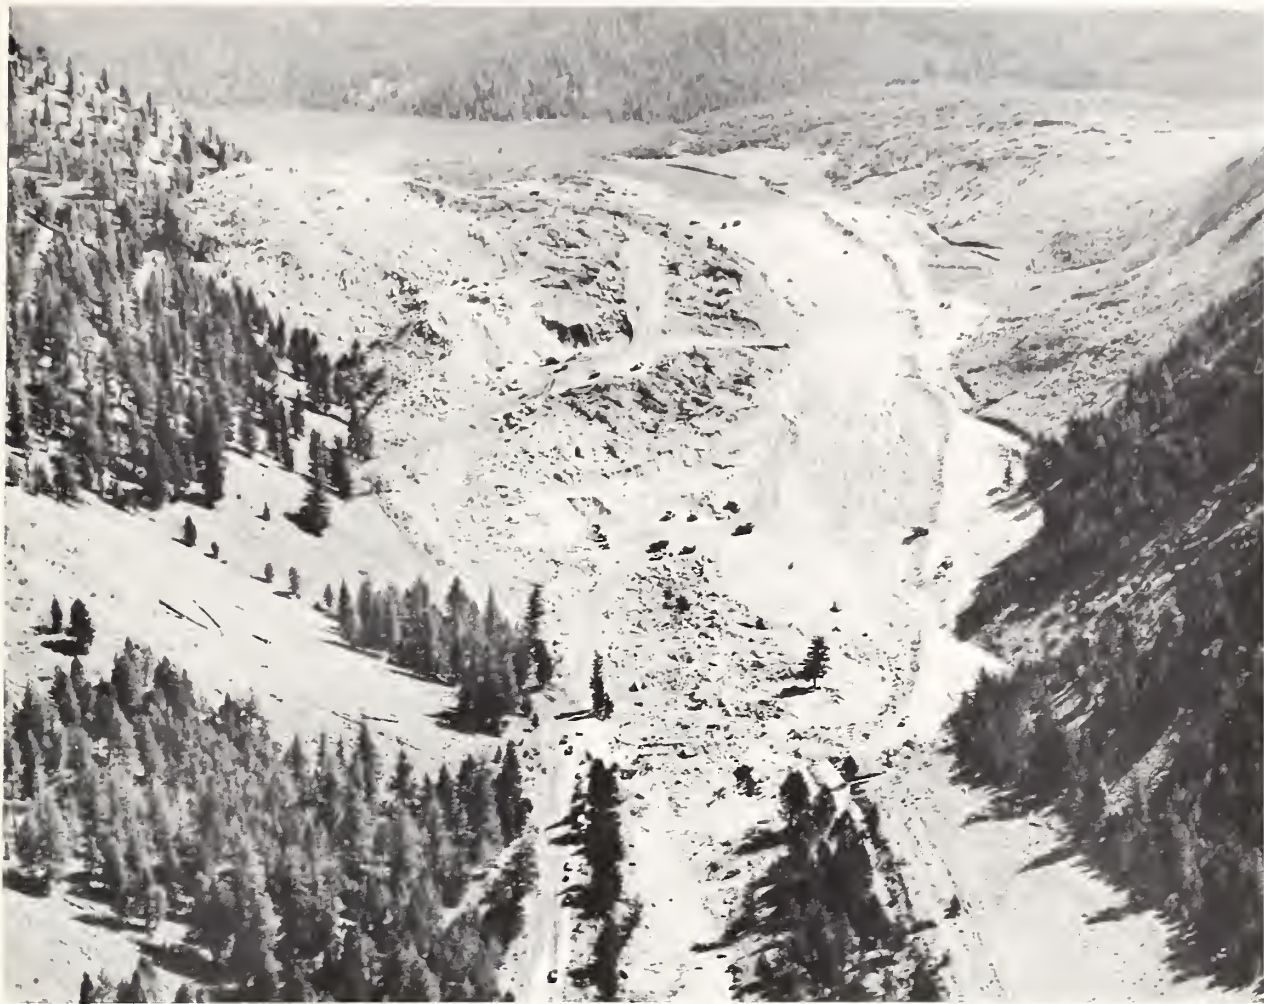
Water flowing from Earthquake Lake through spillway into Madison River. Time: 1:03 p.m., September 10, 1959. Flow of Madison River had been cut off by the slide since August 17, 1959. Note braided flow pattern in lower part of spillway and Madison River in lower center of picture. Vehicles are parked on Montana State Highway 287 and construction roads on the slide.
